TEST REPORT

Wall and ceiling lining tested in accordance with AS
ISO 9705:2003 (R2016) and AS 5637.1:2015

Test sponsor: Briggs Veneers Pty Ltd

To determine the fire hazard properties of veneered FR MDF subjected to a test in accordance with AS ISO 9705:2003 R2016 and AS 5637.1:2015.

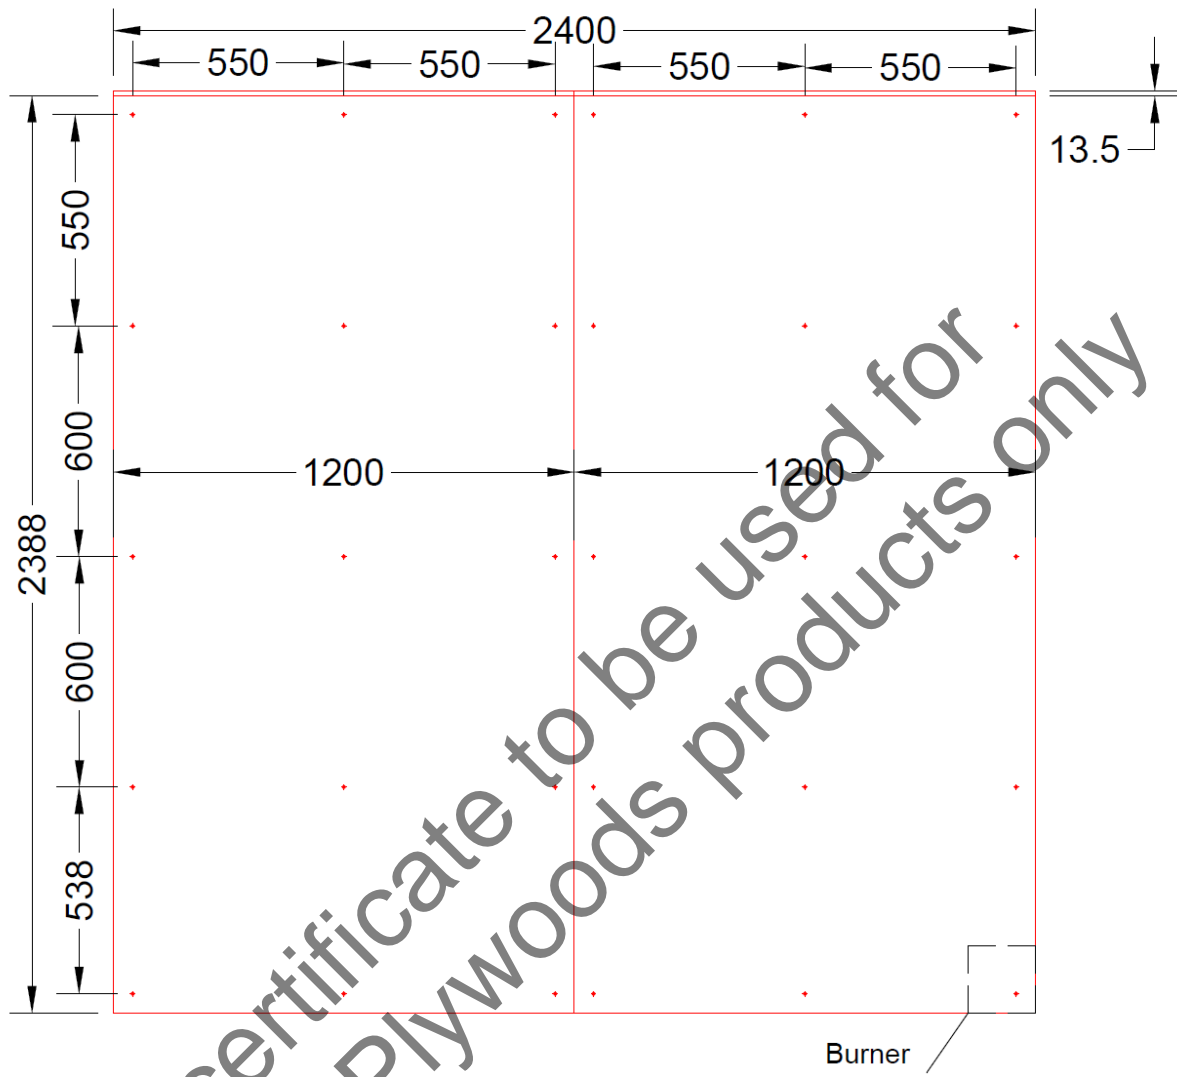
Figure 1 Rear wall

| Quantity | Location | Size (nominal) |
|---|---|---|
| 2 | Rear wall | 1200mm x 2386mm |

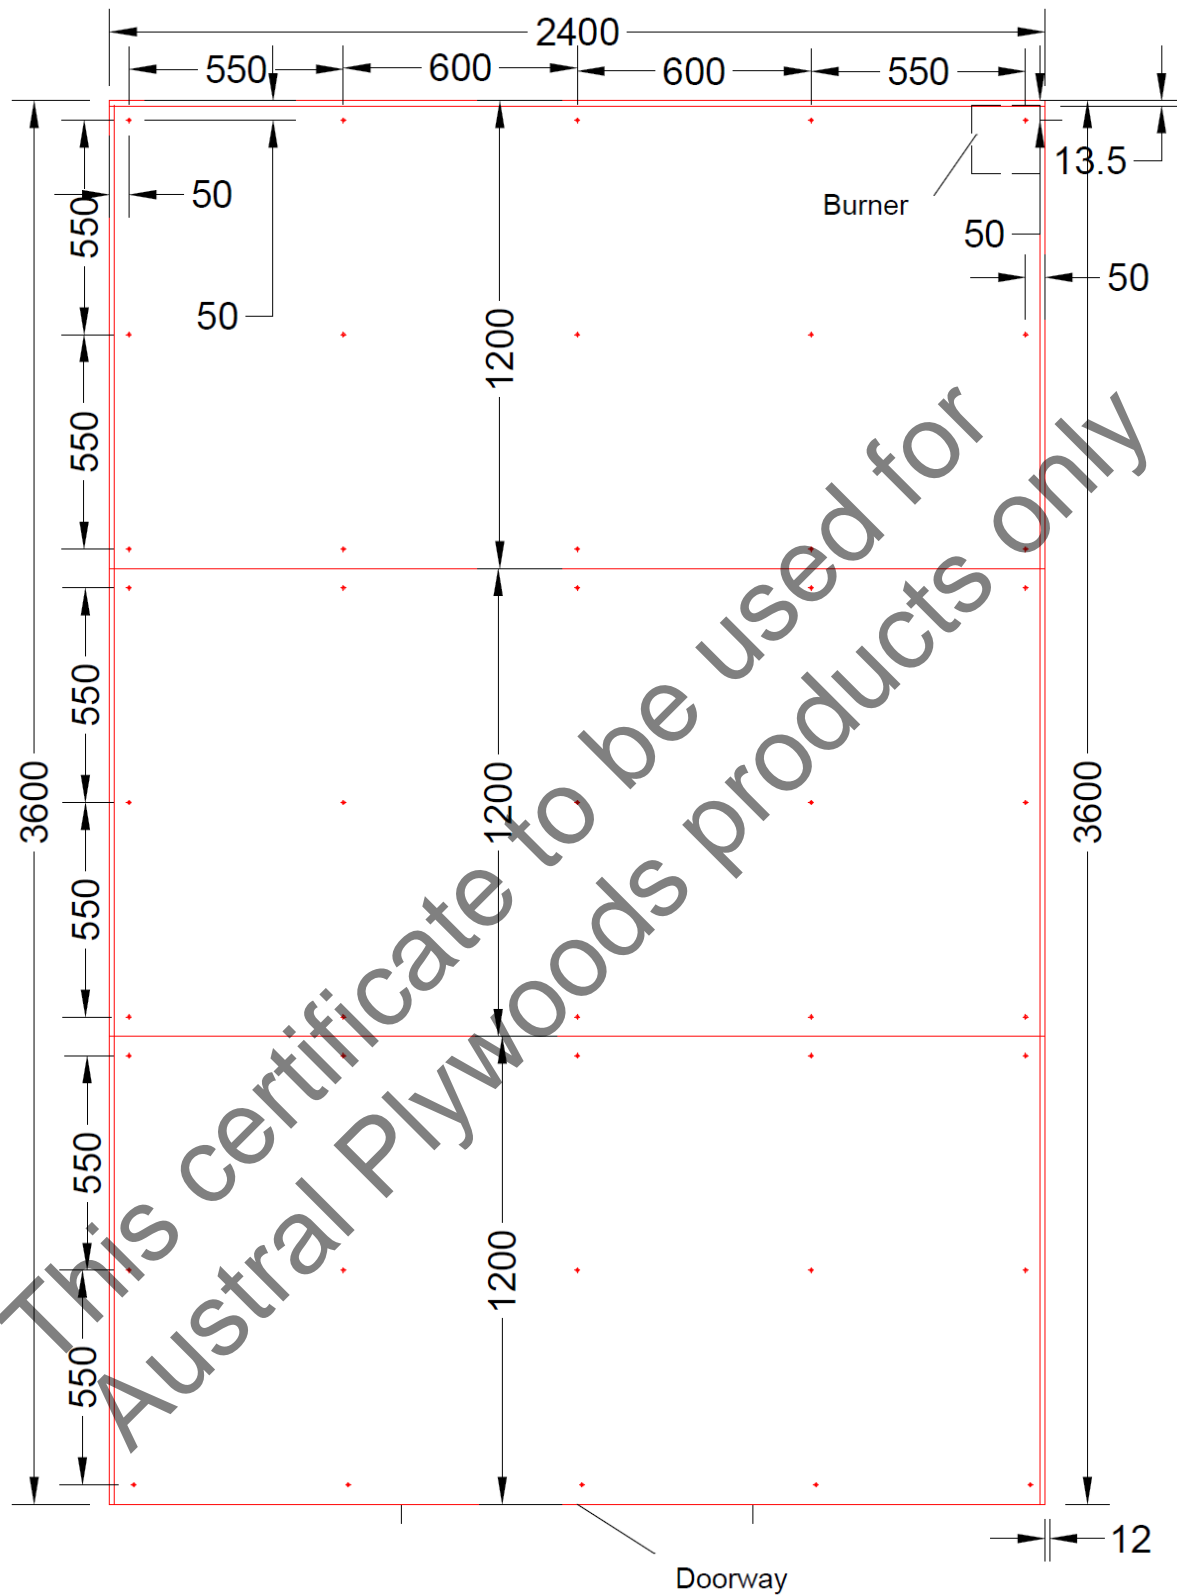
Figure 2 Ceiling (from above)

| Quantity | Location | Size (nominal) |
|---|---|---|
| 3 | Ceiling | 1200mm x 2400mm |

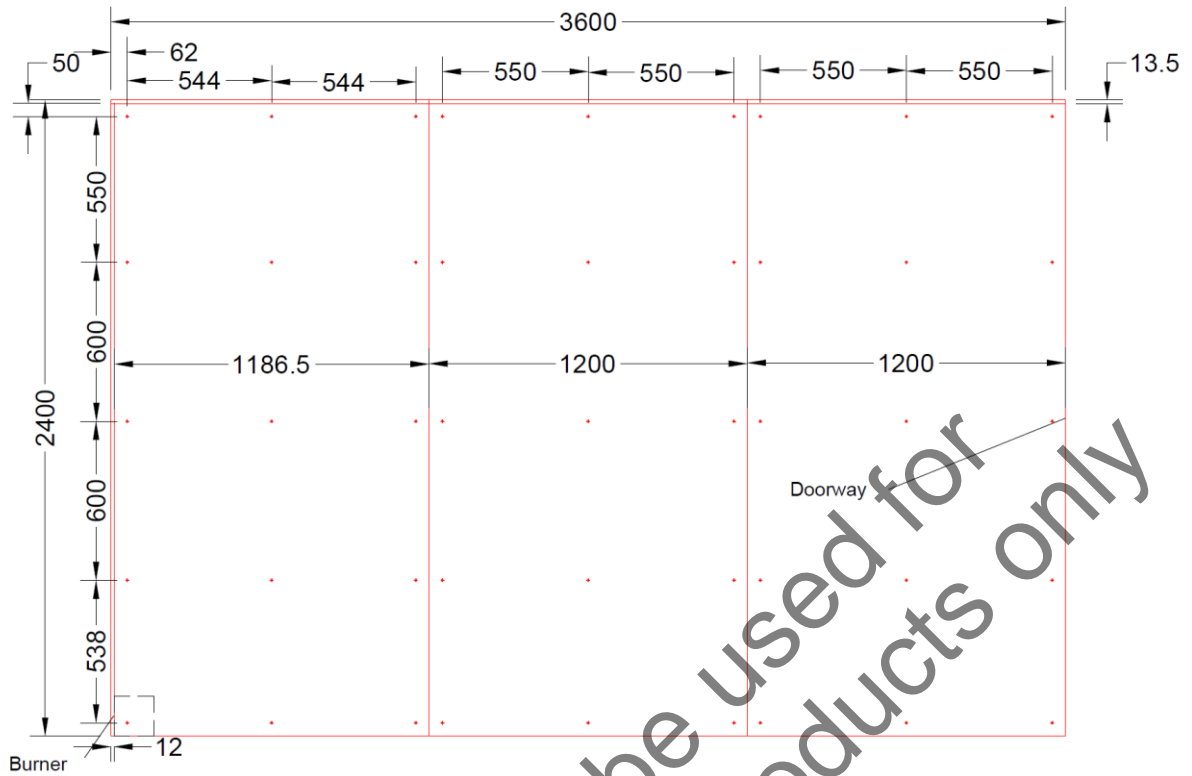
Figure 3 Right wall

| Quantity | Location | Size (nominal) |
|---|---|---|
| 2 | Right wall | 1200mm x 2386mm |
| 1 | | 1186mm x 2386mm |

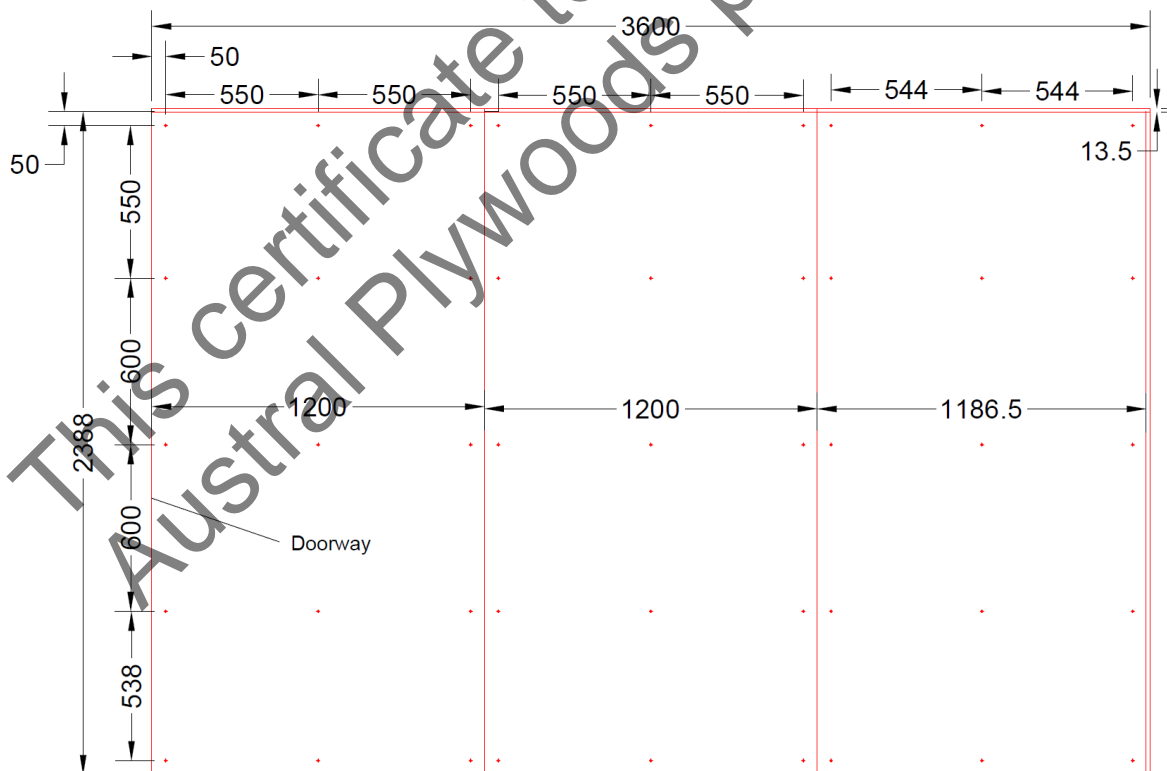
Figure 4 Left wall

| Quantity | Location | Size (nominal) |
|---|---|---|
| 2 | Left wall | 1200mm x 2386mm |
| 1 | | 1186mm x 2386mm |

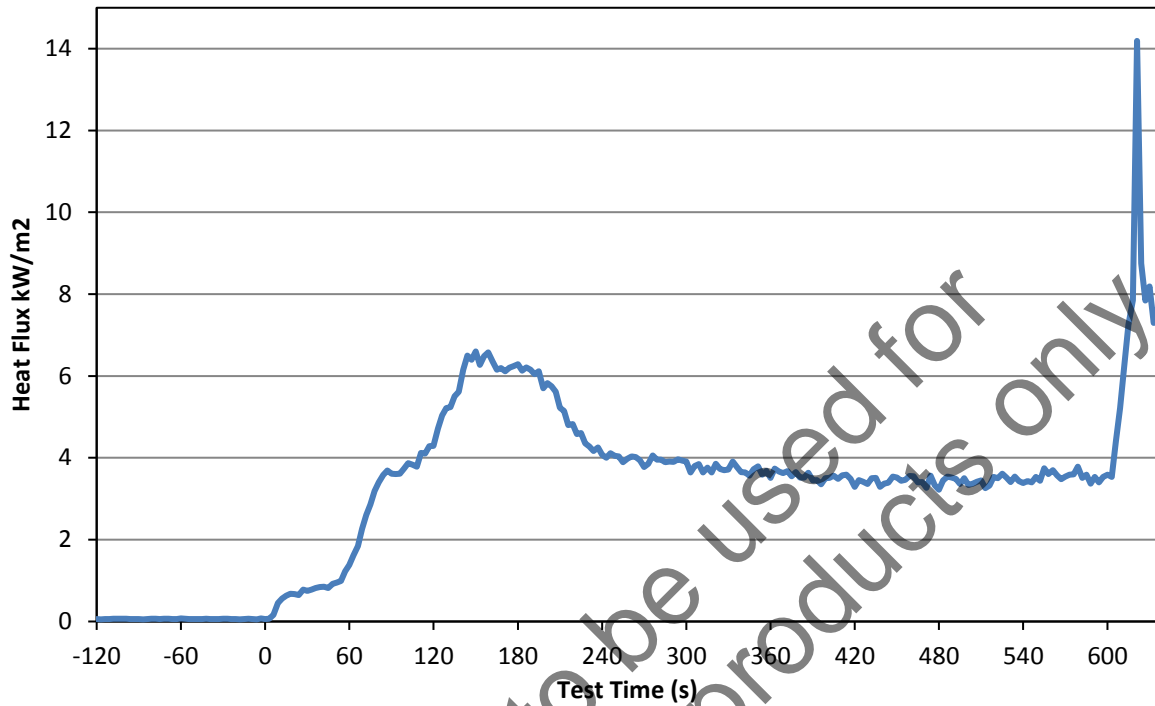
Figure 5 Heat flux vs time

- The heat-flux emanating from the fire generated in the room was measured by a Schmidt-Bolter type heat-flux gauge, placed within the floor in the middle of the room.

The heat flux measurements are provided in Figure 5 in Appendix C.

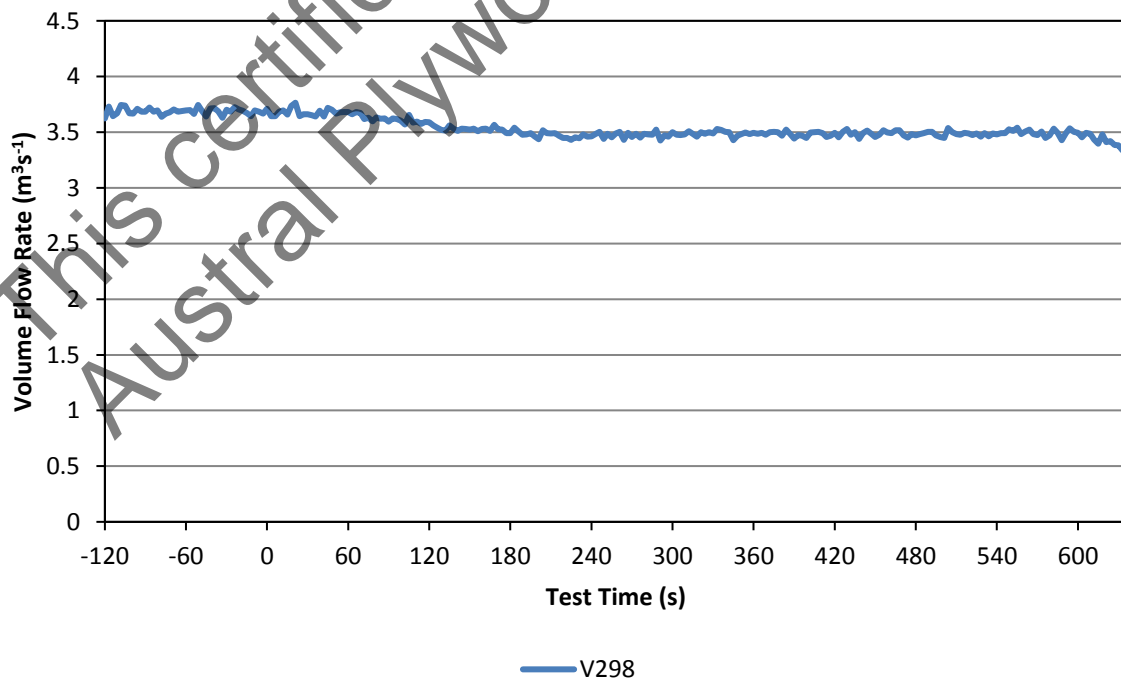
Figure 6 Volume flow rate in duct vs time

- The volume flow rate was determined using bidirectional pressure probe attached to a differential pressure transducer in conjunction with a Type K MIMS thermocouple located near to the probe.

The volume flow rate measurements are provided in Figure 6 in Appendix C.

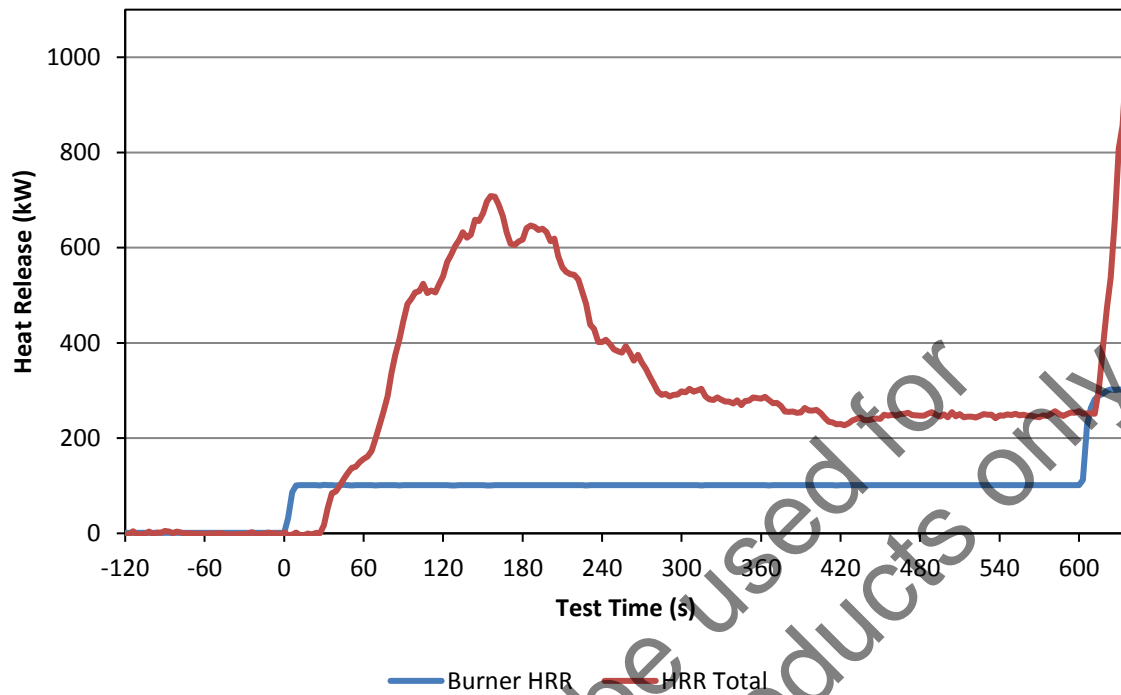
Figure 7 Heat release rate (HRR) of specimen and burner vs time

The rate of heat release from the specimen and the burner are provided in Figure 7 in Appendix C.

The material subjected to this AS ISO 9705:2003 R2016 test achieved a heat release rate of 1 MW after 36 seconds exposure to a 300kW heat source. Therefore, the system has achieved a classification of Group 2.

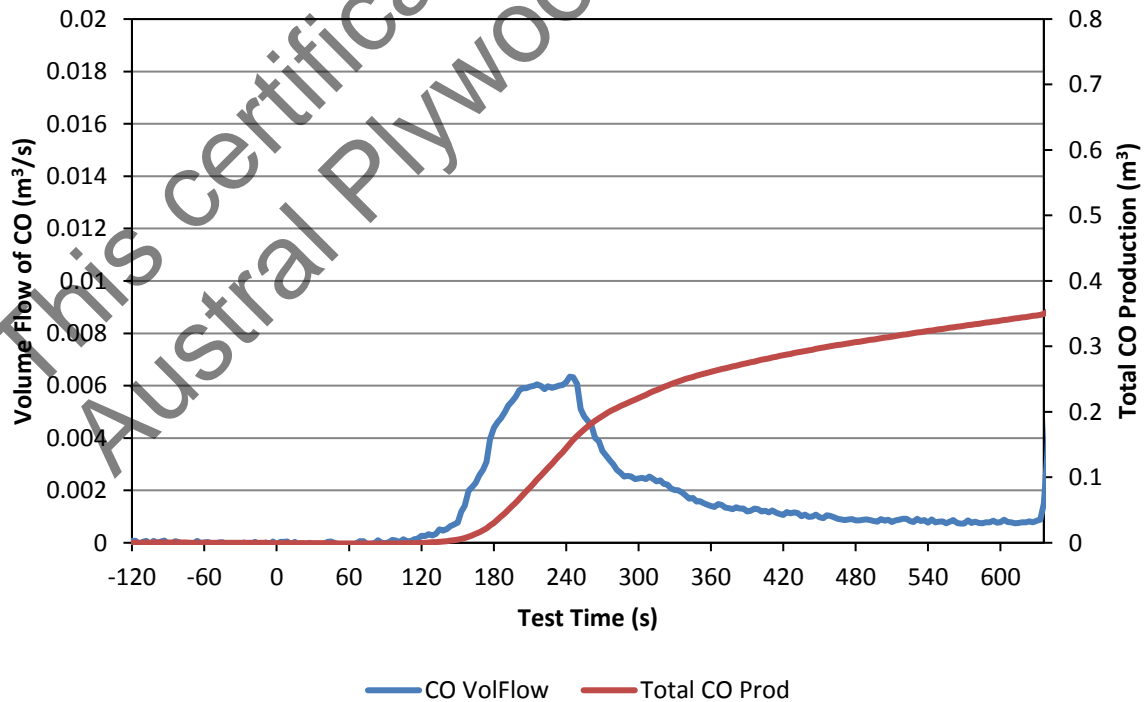
Figure 8 Production of carbon monoxide vs time, at reference temperature and pressure

The rate or production of carbon monoxide and carbon dioxide are given in Figure 8 and Figure 9 respectively in Appendix C.

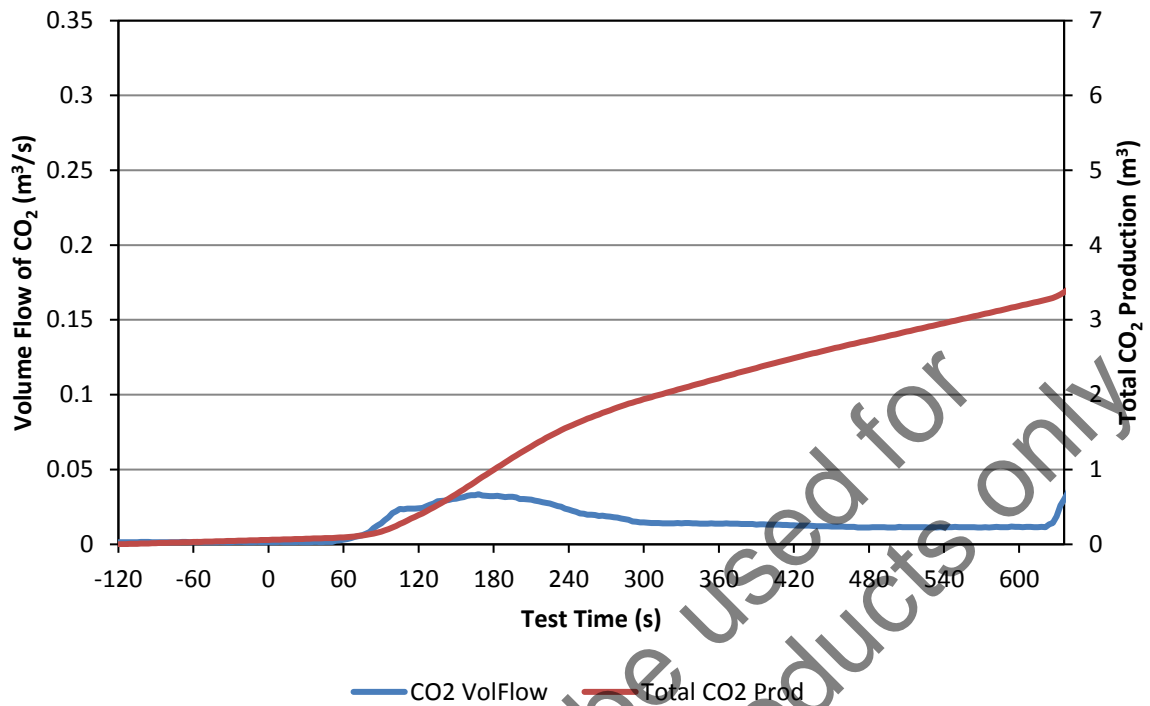
Figure 9 Production of carbon dioxide vs time, at reference temperature and pressure

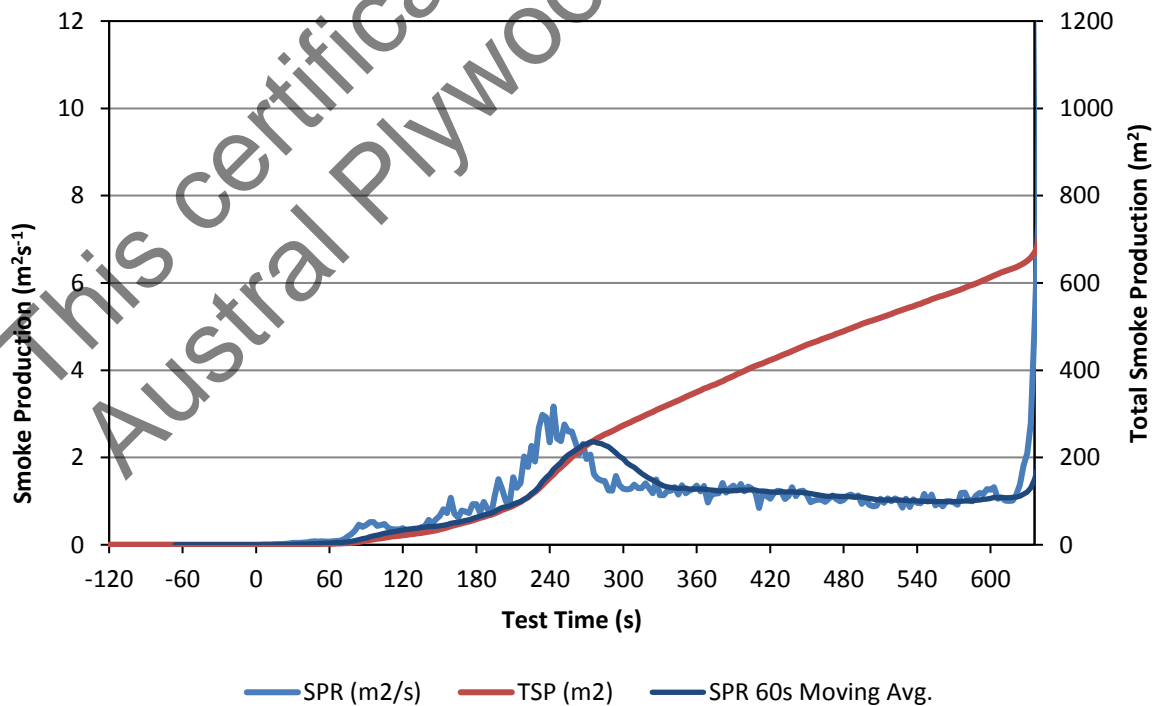
Figure 10 Production of light obscuring smoke vs time, at reference temperature and pressure

The smoke production rate is given in Figure 10 in Appendix C.

The maximum average rate of smoke growth for this material occurred at 618 seconds into the test and was found to be $3.8 \text{ m}^2 \text{ s}^{-1}$. Therefore, the $SMOGR_{RC}$ (in $\text{m}^2 \text{ s}^{-2} \times 1000$) value for the material is 4.7.

Between 0 and 10 minutes of the test period the average smoke production rate was $0.77 \text{ m}^2\text{s}^{-1}$, therefore the C/VM2 – Verification Method: Framework for Fire Safety Design classifies this material as Group 2 – S.

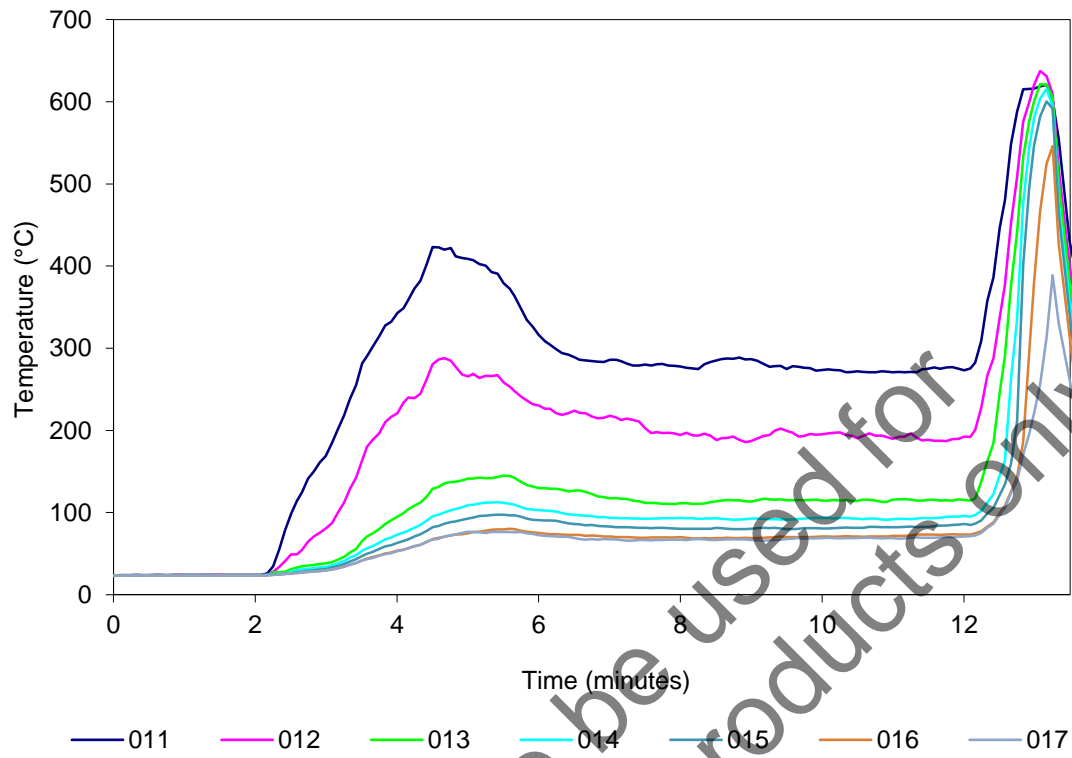
Figure 11 Temperature at height in the corner opposite to the burner vs time
 05: 2.00m 06: 1.72m 07: 1.57m 08: 1.42m 11: 1.27m 12: 0.70m 13: 0.67m
 (from the room floor)

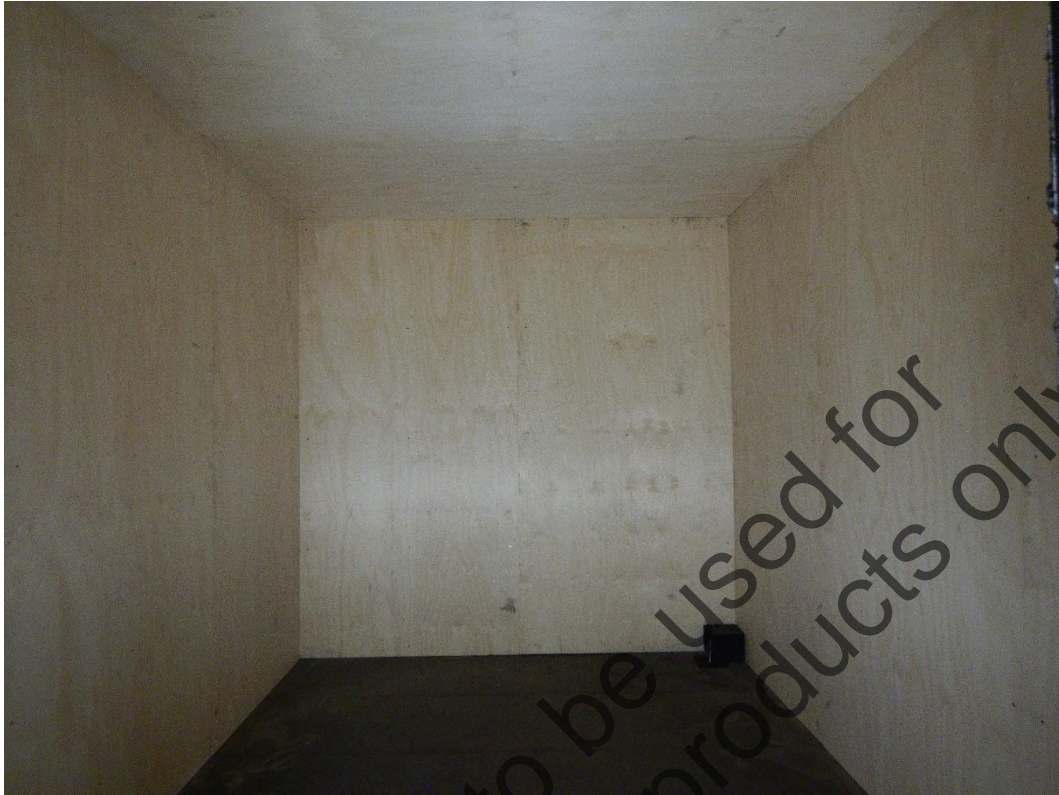
Figure 12 The specimen before commencement of the reaction to fire test

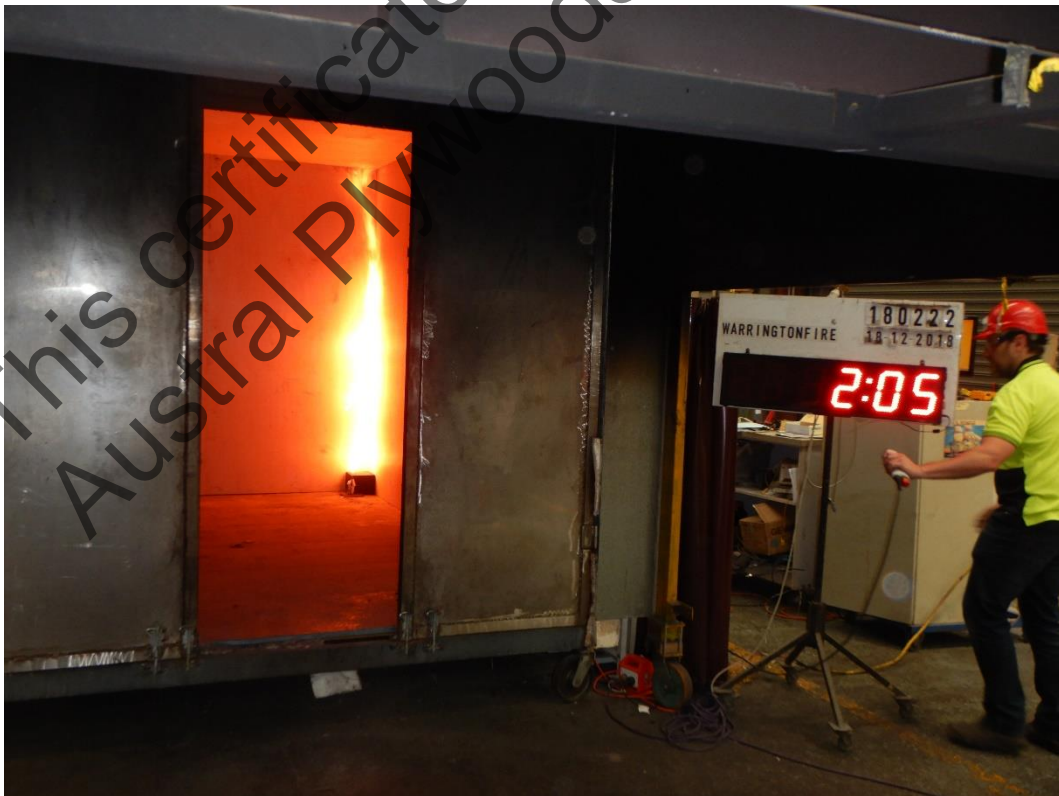
Figure 13 Specimen 5 seconds after ignition of burner.

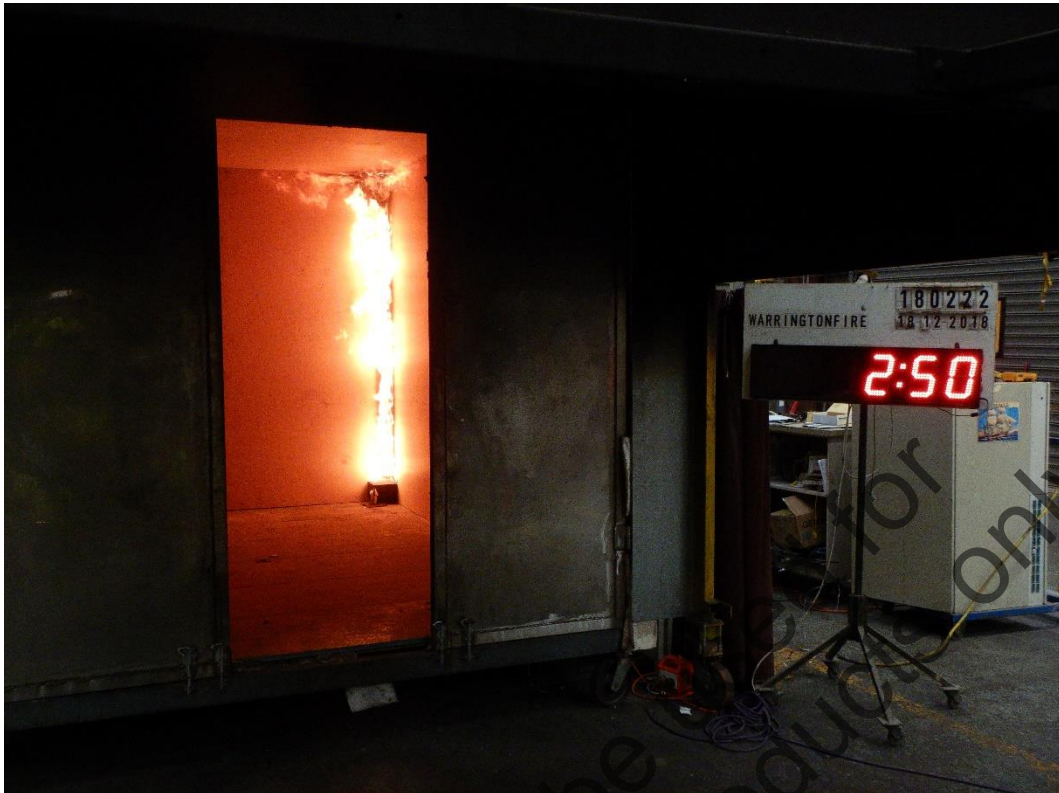
Figure 14 Specimen 50 seconds after ignition of burner.

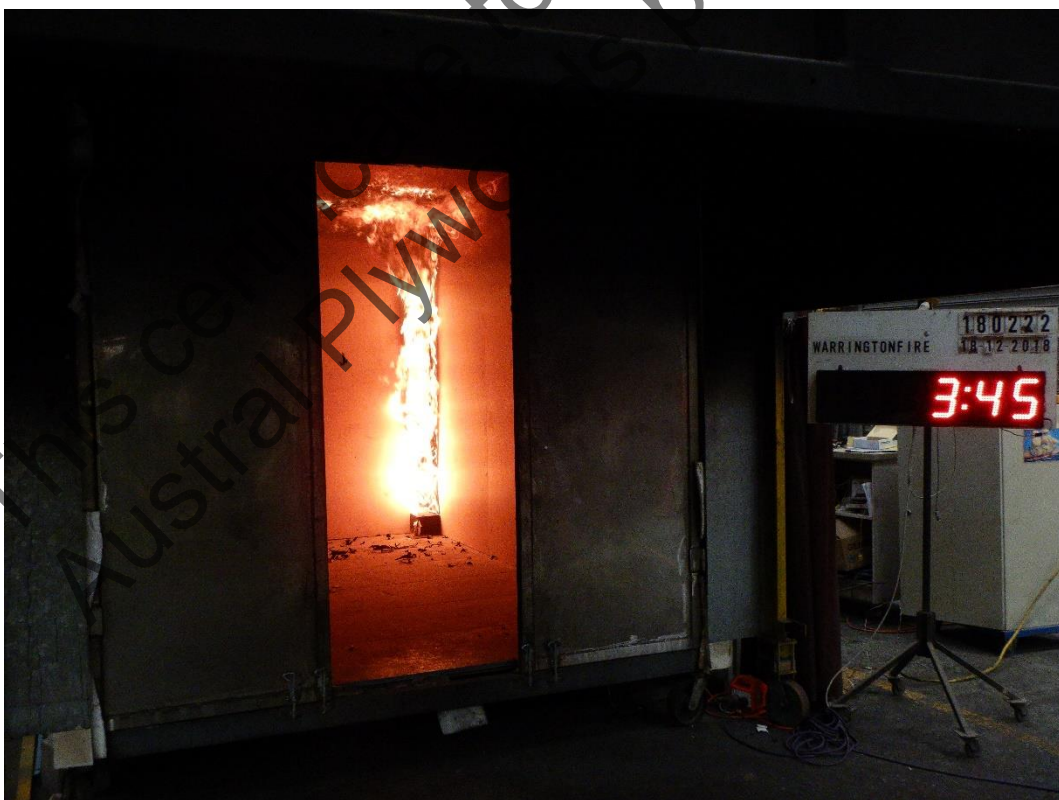
Figure 15 Specimen 1 minute and 45 seconds after ignition of burner.

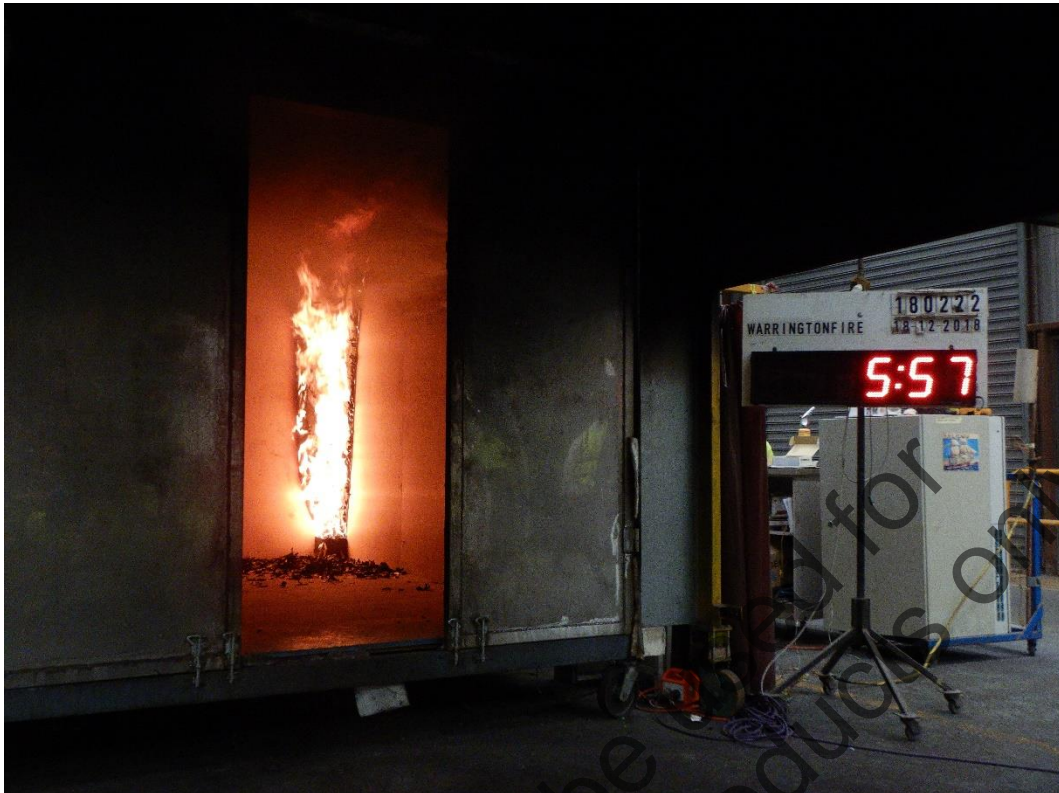
Figure 16 Specimen 3 minute and 57 seconds after ignition of burner.

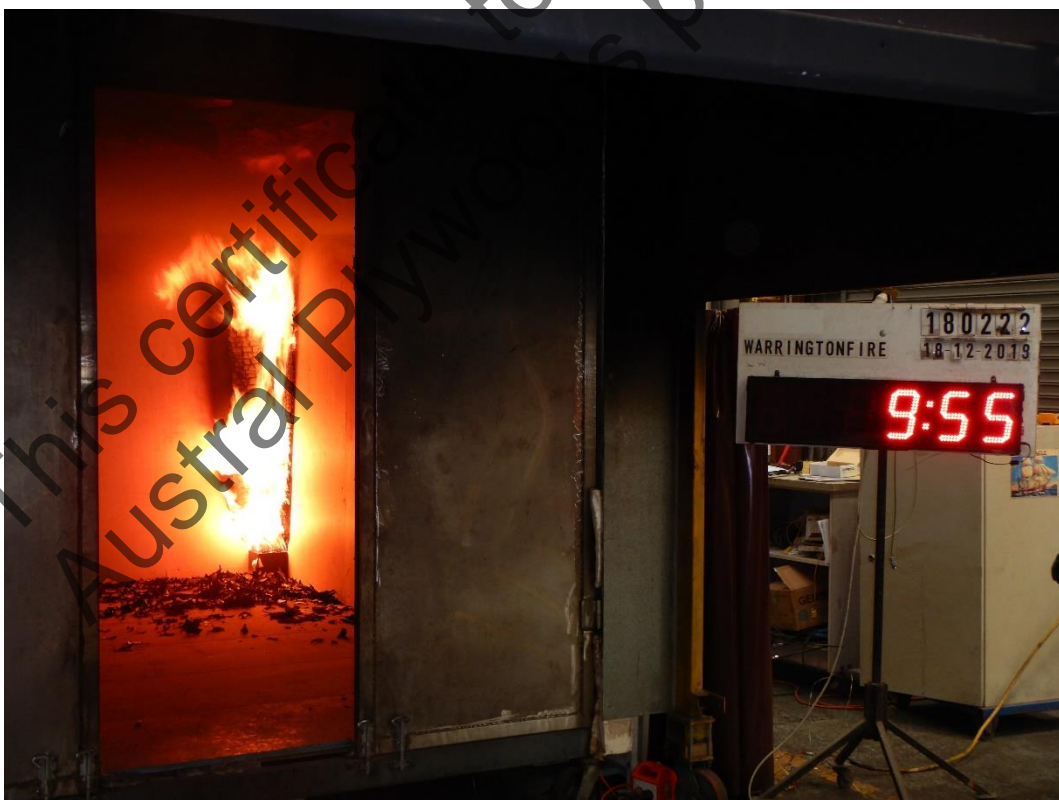
Figure 17 Specimen 7 minute and 55 seconds after ignition of burner.

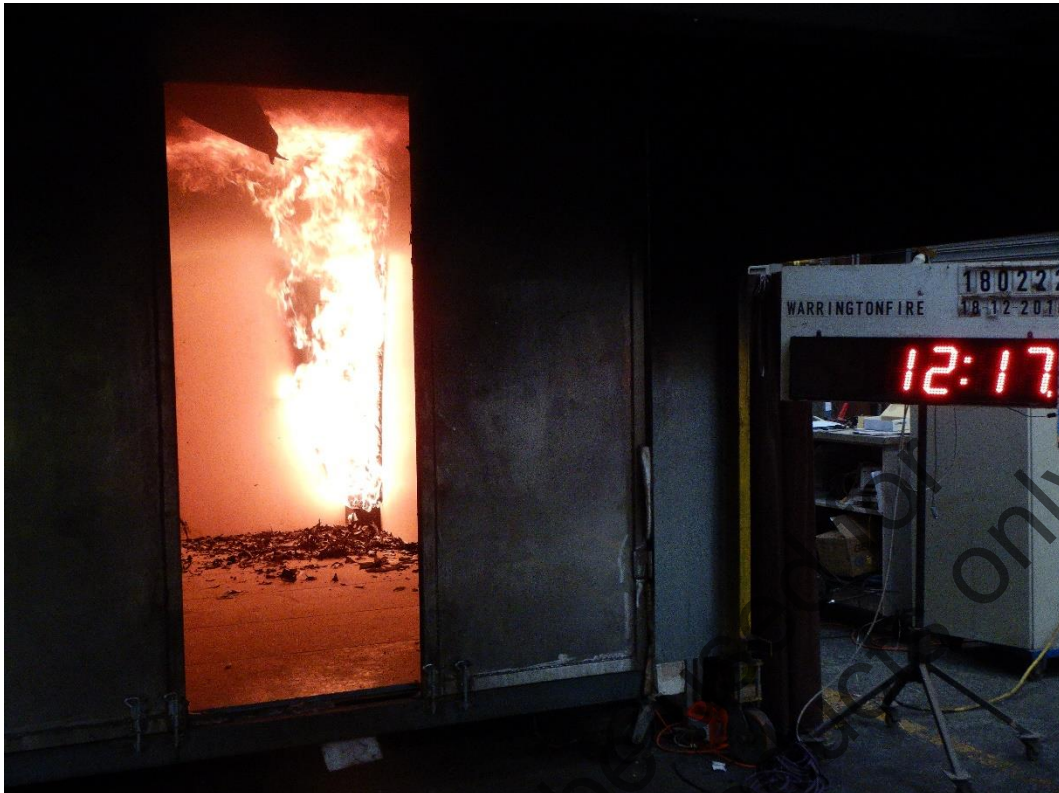
Figure 18 Specimen 17 seconds after burner output was increased to 300kW.

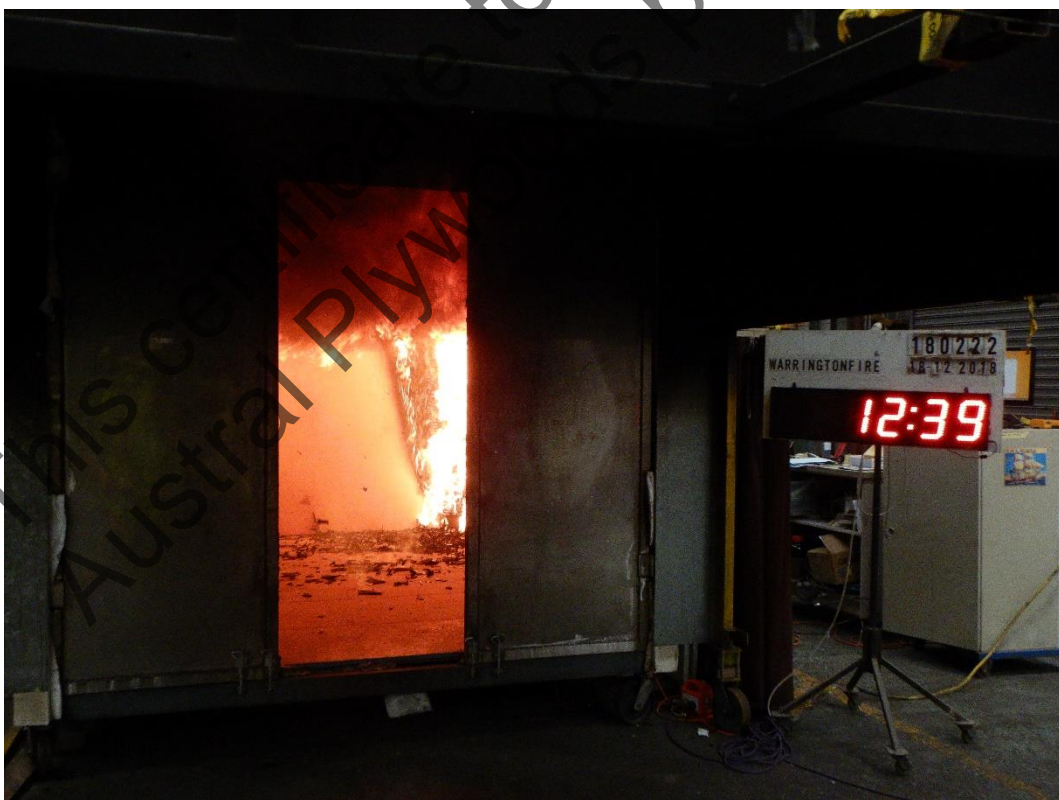
Figure 19 Specimen at flashover.

The flashover occurred 756 seconds, i.e. 636 seconds after burner ignition.

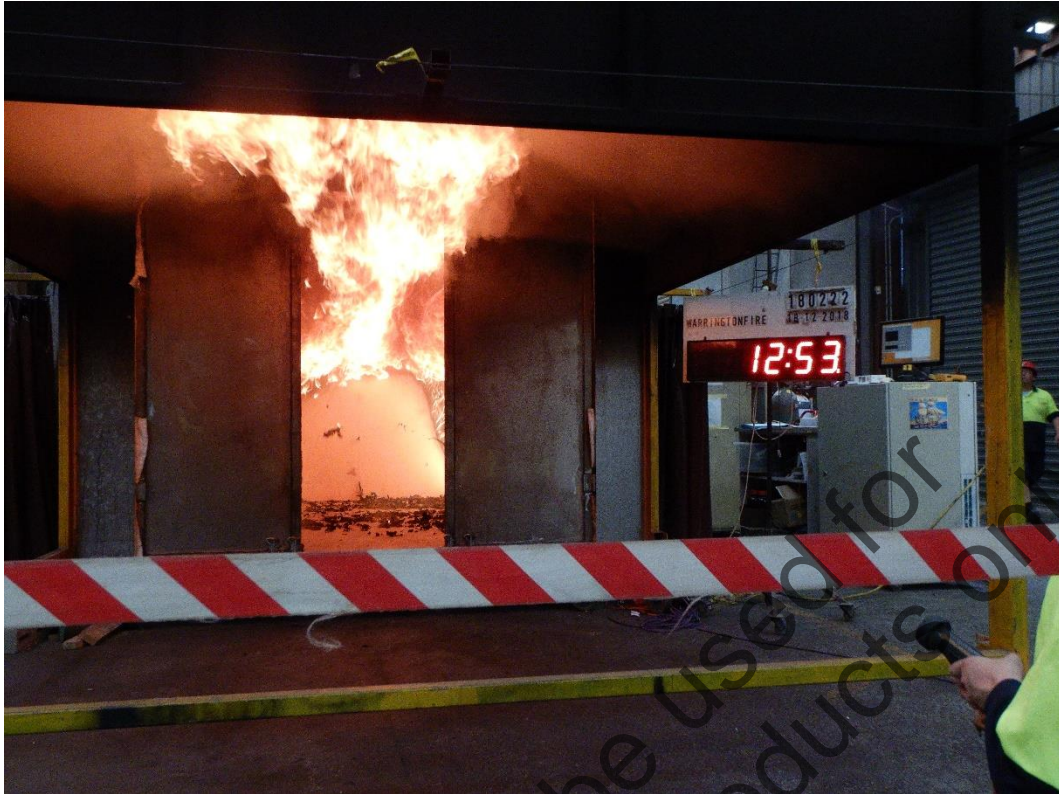
Figure 20 Specimen at the end of the reaction to fire test.

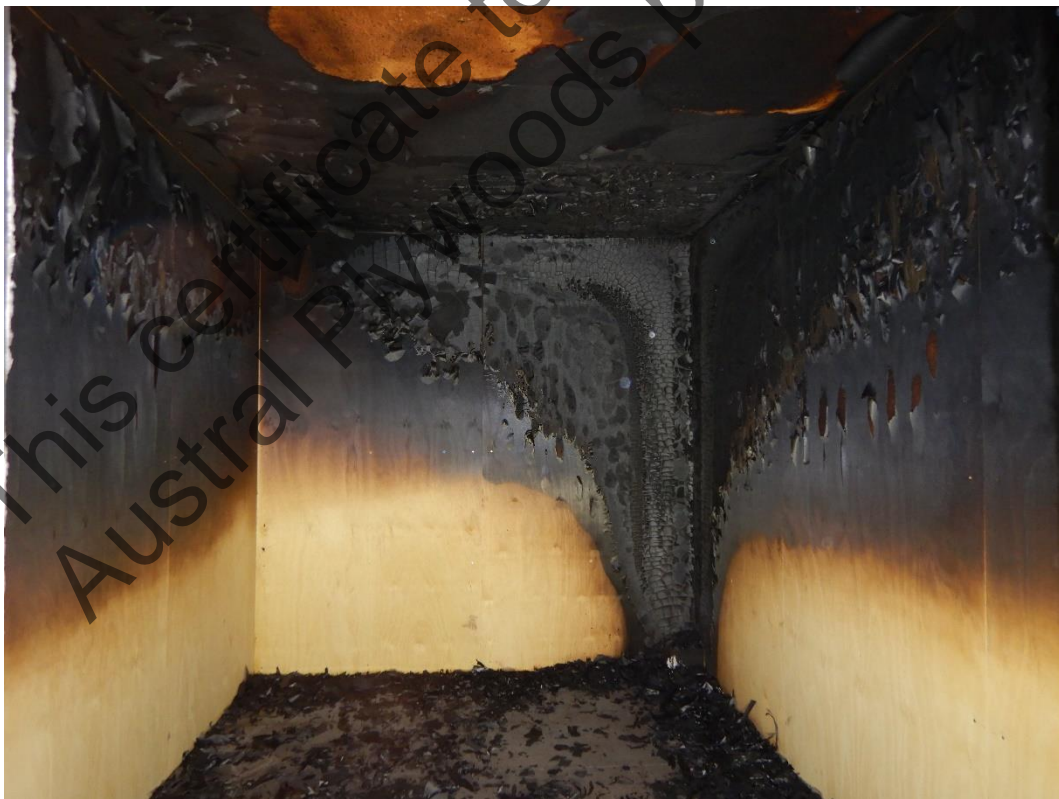
Figure 21 The specimen after the reaction to fire test
